Technical Report 964

**SURVIVAL AND GROWTH OF RED
MANGROVES (*Rhizophora mangle* L.)
PLANTED UPON MARL SHORELINES
IN THE FLORIDA KEYS**

A Five-Year Study

1 May 1984
Final Report

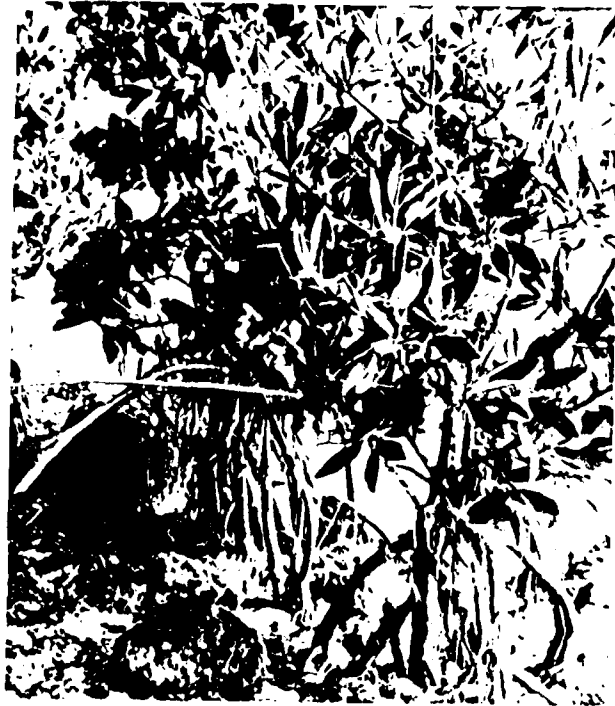
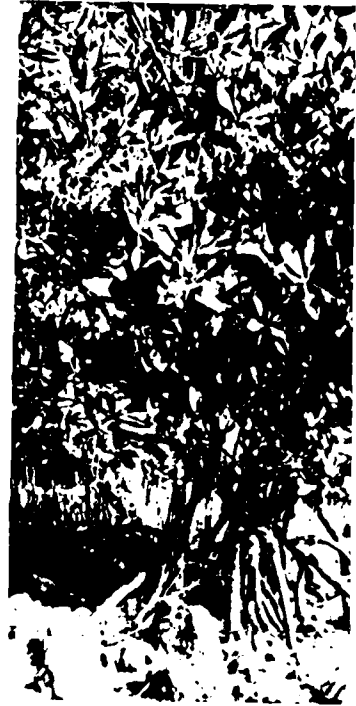
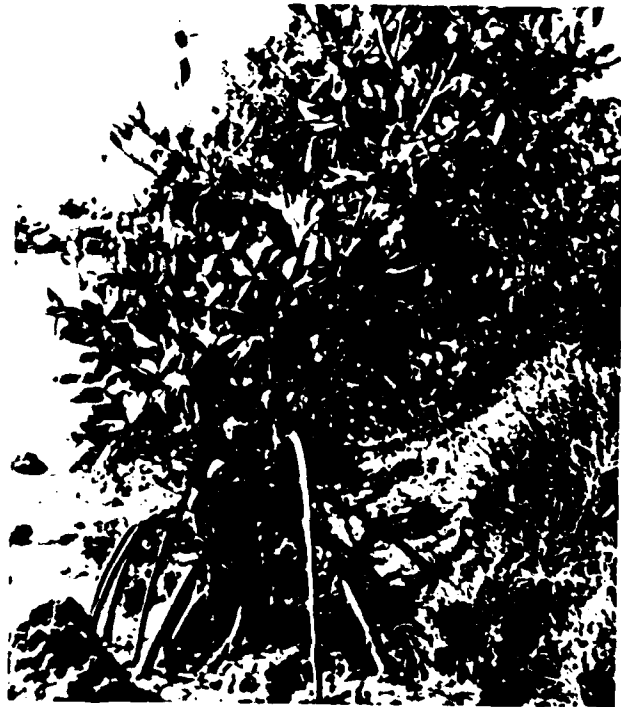
Figure 6 Typical growth pattern exhibited by type C plants on the exposed shoreline (site B) after

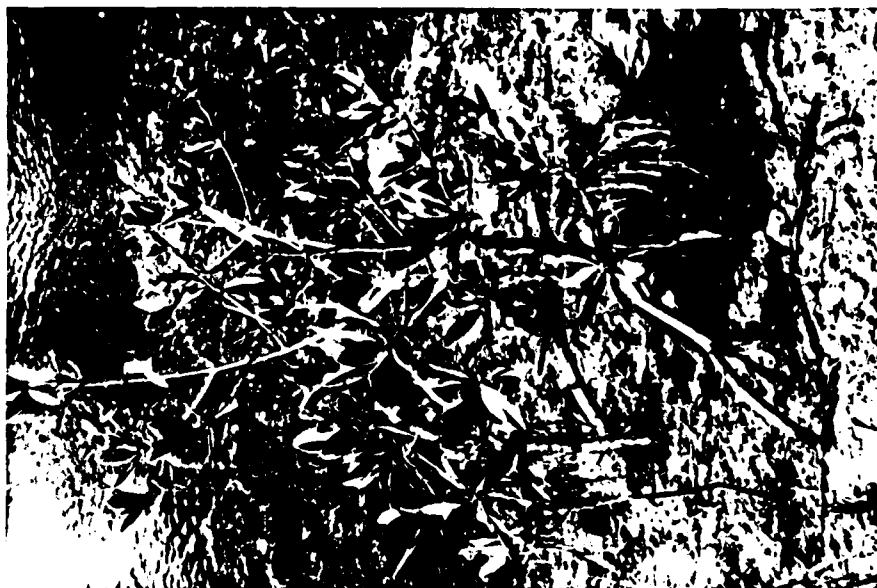
Figure 7. Typical growth pattern exhibited by type C plants on the partially protected shoreline (site C) after 5 years (1977-1982).

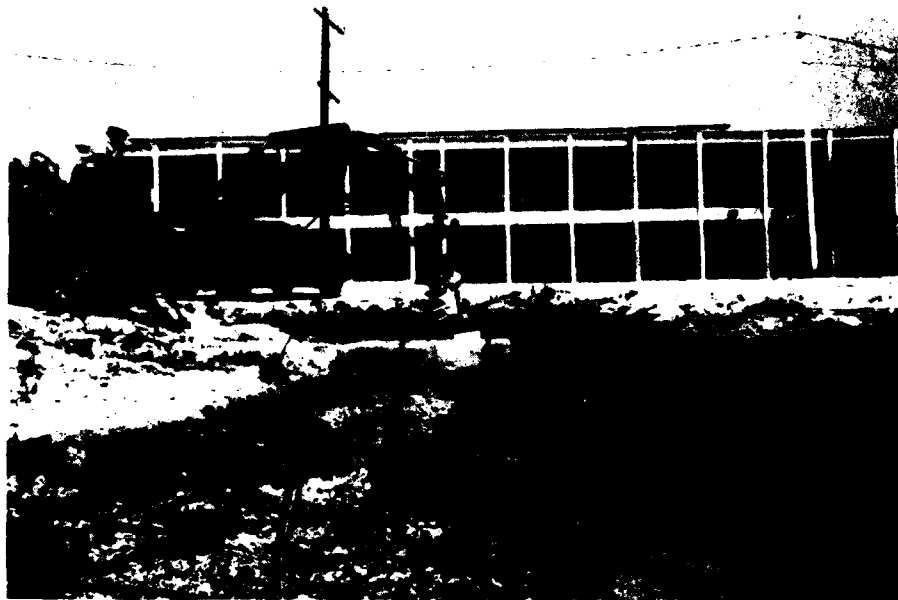
Figure 8. Condition of protected shoreline (site A) in 1977 (10 years after placement of marl).

Survival for all plant types was greater (68%) at the +0.3-m tidal height than at 0.0 m (29%) at all sites. Figures 8, 9, 10 and 11 show the conditions on the protected and exposed shores (sites A and B) before and 5 years after the transplant. The difference in mangrove community development at these sites is quite evident and may be explained by differences in rates of organic debris accumulation. Figure 12 shows the condition of sites D and E (control shorelines) 15 years after placement of marl (1982).

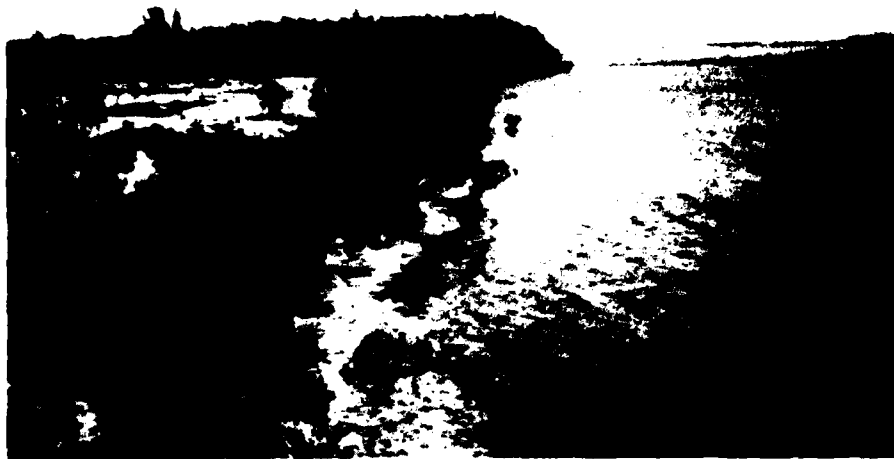
Figure 11. Revegetated condition of exposed shoreline (site B) in 1982 (5 years after mangrove transplant).

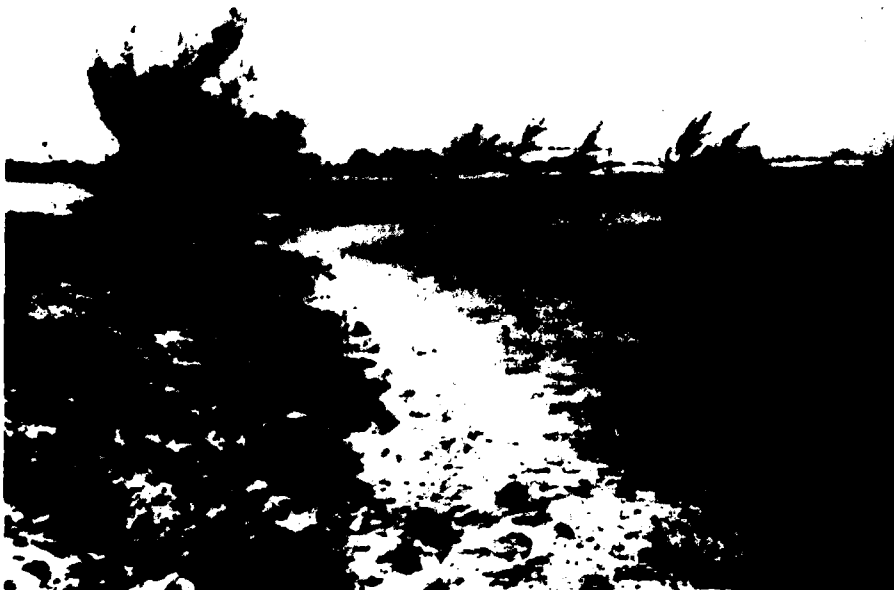
Figure 12. Eroding, unvegetated condition of control shorelines (sites D, foreground and E, background) in 1982 (15 years after placement of marl).

It appears that the unusually windy weather in the Keys during the past few winters may have been responsible for the observed decrease in survival of propagules and seedlings and the increase in growth of the larger trees. In sharp contrast to the transplanted shorelines the natural vegetation of the control shores (sites D and E) was limited to a few small seedlings. Without the protection afforded by transplanted mangroves, these shores have continued to erode throughout the 5 years of this study.
